„The conservation and revitalization of the Benedek Manor House in the city of Gheorgheni”

– *Chronicles of the Facade* –

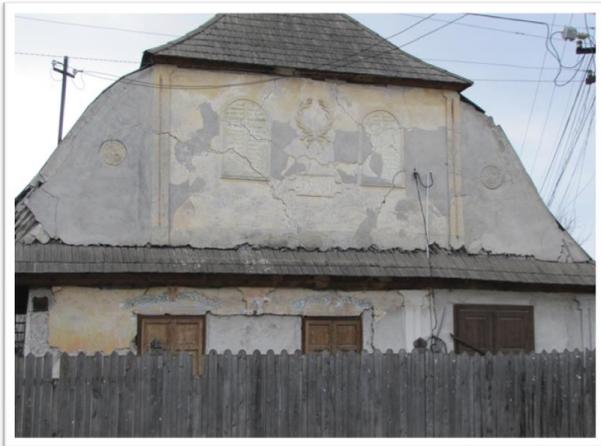
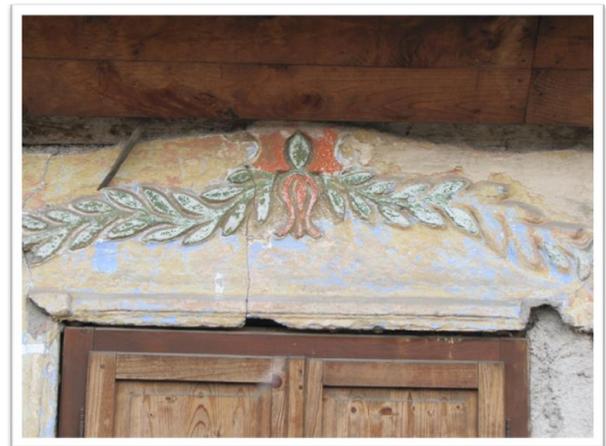
Building archeology has revealed that the facade of the Benedek Manor House from the city of Gheorgheni, listed as a B. cat. monument, presents not only five different layers of plaster and coat, but also valuable, in situ pieces of the original strata, dating almost two centuries back.¹

The test holes opened on different surfaces demonstrated that the facade of the manor house has five different coats from different periods of the construction. The original layer, dating back to 1840, was found between the main shoulder and the windows. The other

surfaces are coated with simple, polychrome dyestuff, according to the archeologic research.

Five coloured layers have been put on the first coat of plaster – the basic layer is white, while the stucco ornaments have been pointed out by colourful spots. The laureate-floral stucco ornaments of the facade are also original pieces of chrome oxid green and bright red. The fragmented capital of the only original column and the column itself have originally been painted with orange-ochre, having brownish-blackish cannelures in the middle.

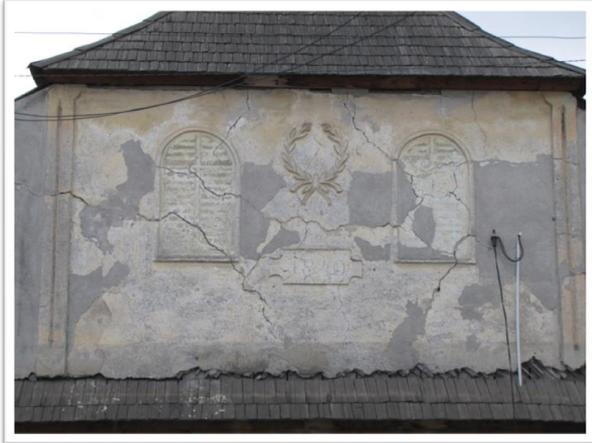
The frontispiece presents ornaments similar to the ones in the lower parts of the facade.

In the middle, there is another laureate-ornament with the inscription of 1840 underneath, still legible, which probably refers to the year of construction.

On the two sides of the inscription, there are two cambered, false windows framed with „towed” profiles and greenish dye that imitates venetian blinds.

The plaster coat both on the lower parts of the wall and the frontispiece are two-coat works put on lath. The first coat is of coarse grained, 1-2 cm thick layer, then a thin, smooth, 0,5 cm thick, grey-ochre coat was laid on, ended up by a smooth whitewash layer.

Year by year the binder has lost its power, so that the walls have reached to a sorrowful state; moreover thick, hard whiting layers have been put on later, which make it hard to reveal the original techniques.

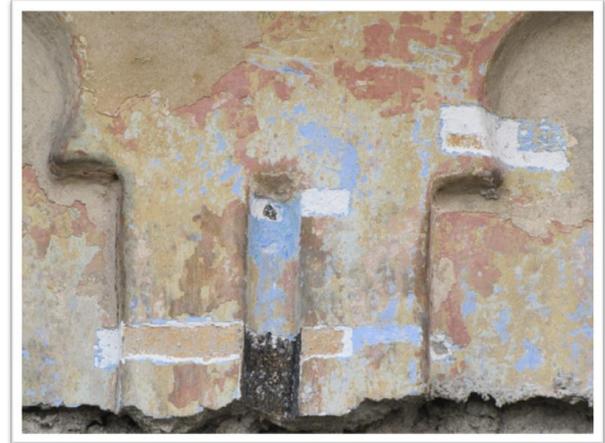
The frontispiece and the lower part present two very different states, which lead to the conclusion that they might tell the story of two different periods of construction. The

truth is, that the presence of the main shoulder was highly beneficial for the facade, since the upper part has strongly been affected by weather conditions, but the lower parts were kind-of protected, and as a result, several original pieces could have remained in quite a good state.

The continuous small movements of the studding, a fissure-net has formed on the whole surface of the facade, unfortunately highly intensified by the heavy traffic flowing in the immediate proximity of the manor house.

The most important and most urgent steps in the process of rehabilitation are the consolidation and conservation of the original pieces of plaster coat, in order to stop further erosion.

Because of the unstuck pieces of the plaster work and its disfunctional presence in many spots, the proper covering up and subinjection are an absolute necessity in the most damaged parts. When bracing and

stabilization is over on the whole surface, brushing and scouring can follow, then the filling of unevennesses. After the cleaning process, the plaster needs to be stabilized with silicic acid ester. The last step is aesthetic completion, using the so called *Trataggio* retouch technique. In this way, we can reach to the image that resulted from the construction techniques used two centuries ago.
